# REPORT ON COOL PAINT APPLICATION IN SHANABHAI'S HOME MAY 2021

The application of cool paint had been successfully carried out and reported. The temperature measurement with thermal camera carried out in afternoon to target maximum radiation.

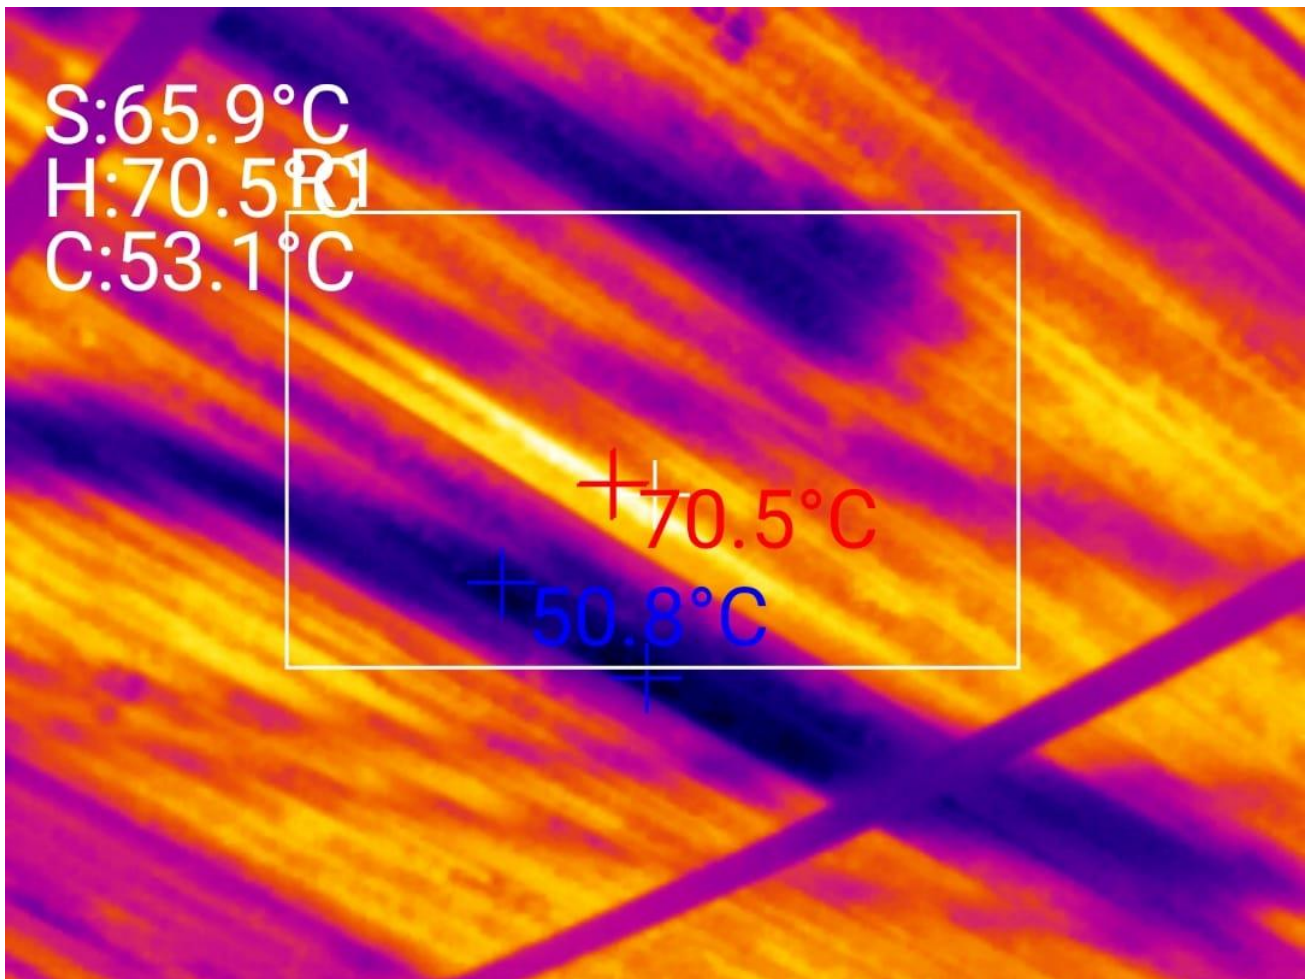
**AFTERNOON DATA BEFORE APPLICATION OF COOL PAINT FOR CORRUGATED  
STEEL SHEETS OUTER FACE, 3<sup>rd</sup> May 2021 (Ambient Temp. 40° C)**

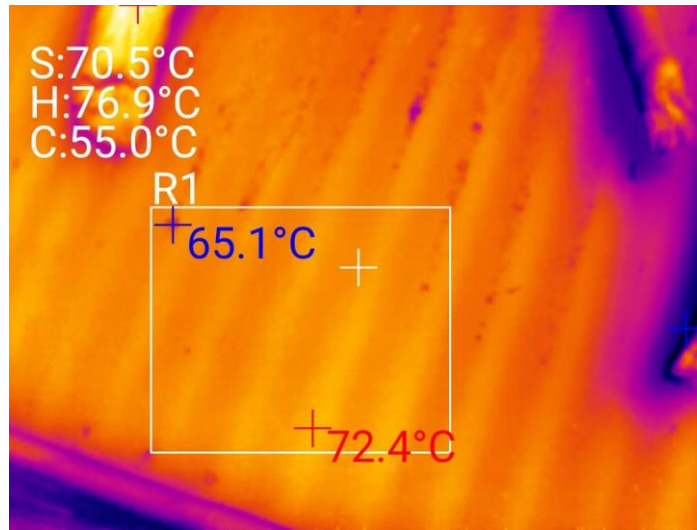
**AFTERNOON DATA BEFORE APPLICATION OF COOL PAINT FOR CORRUGATED STEEL SHEETS OUTER FACE, 4<sup>th</sup> May 2021 (Ambient Temp. 40° C)**

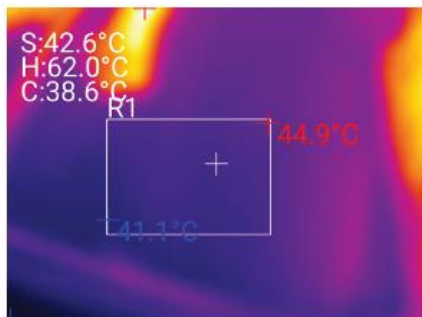
**AFTERNOON DATA AFTER APPLICATION OF COOL PAINT ON CORRUGATED STEEL SHEET OUTER FACE, 11<sup>th</sup> June 2021 (Ambient Temp. 37° C) FOR COOL PAINT**

File name:	20210611145449.hir	Emissivity value:	0.95
Date of saved image:	20210611145449	Ambient temperature:	25.0°C
GPS info:	22.50639,73.00305	Reflected Temperature:	25.0°C
Max temp value:	61.0°C	Min temp value:	38.0°C

Name	Type	Temp
R 1	Max	44.9°C
	Min	41.1°C
	Average	42.8°C

**SO, REDUCTION OF 72.4 – 44.9 = 27.5 °C NOTED**

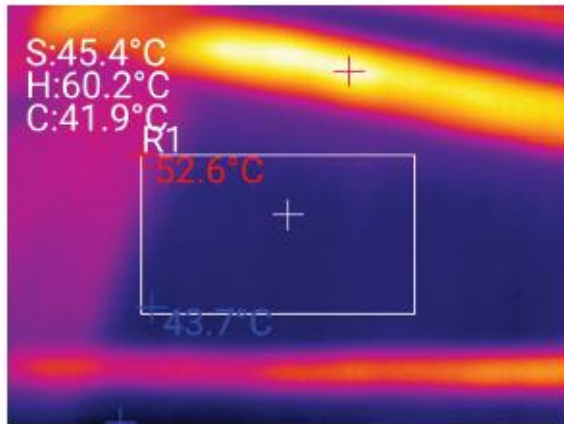
**AFTERNOON DATA AFTER APPLICATION OF COOL PAINT ON CORRUGATED STEEL SHEET OUTER FACE, 11<sup>th</sup> June 2021 (Ambient Temp. 37° C) FOR KHADI PRAKRUTIK PAINT**

<b>File name:</b>	20210611145437.hir	<b>Emissivity value:</b>	0.95
<b>Date of saved image:</b>	20210611145437	<b>Ambient temperature:</b>	25.0°C
<b>GPS info:</b>	22.503056,73.00472	<b>Reflected Temperature:</b>	25.0°C
<b>Max temp value:</b>	63.0°C	<b>Min temp value:</b>	42.0°C

Name	Type	Temp
R 1	Max	52.6°C
	Min	43.7°C
	Average	45.9°C

**SO, REDUCTION OF 72.4 – 52.6 = 19.8 °C NOTED. THE DIFFERENCE IN REDUCTION OF OUTER SURFACE TEMPERATURE IS OBSERVED TO BE 27.5-19.8 = 7.7 °C. SO, FURTHER TECHNOECONOMIC COMPARASION SHOULD BE CARRID OUT BETWEEN KHADI PRAKRUTIK PAINT AND COOL PAINT TO EVALUATED OPTIMUM PAINT APPLICATION.**

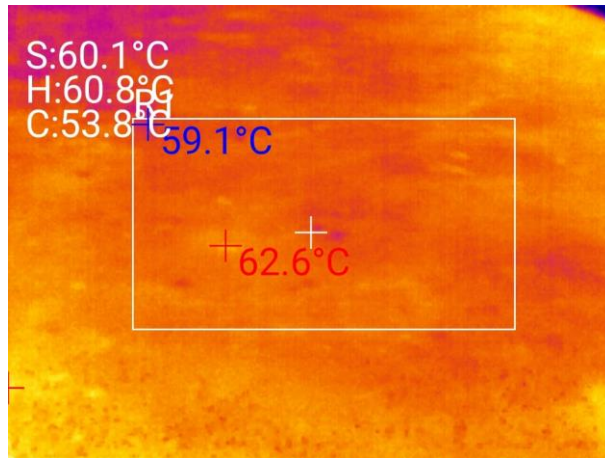
**AFTERNOON DATA BEFORE APPLICATION OF COOL PAINT FOR RCC SLAB  
OUTER FACE, 4<sup>th</sup> May 2021 (Ambient Temp. 40° C)**

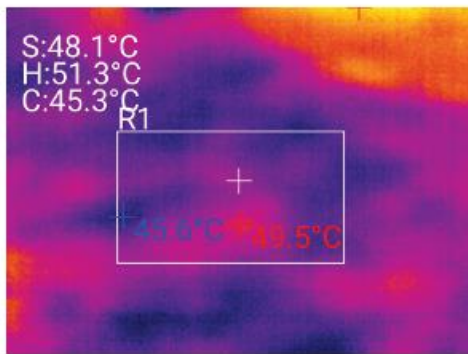
**AFTERNOON DATA AFTER APPLICATION OF COOL PAINT FOR RCC SLAB OUTER  
FACE, 11<sup>th</sup> June 2021 (Ambient Temp. 37° C)**

<b>File name:</b>	20210611145425.hir	<b>Emissivity value:</b>	0.95
<b>Date of saved image:</b>	20210611145425	<b>Ambient temperature:</b>	25.0°C
<b>GPS info:</b>	22.503056,73.00472	<b>Reflected Temperature:</b>	25.0°C
<b>Max temp value:</b>	51.0°C	<b>Min temp value:</b>	45.0°C

Name	Type	Temp
R 1	Max	49.5°C
	Min	45.6°C
	Average	47.6°C

**SO, REDUCTION OF 62.6 – 49.5 = 13.1 °C OBSERVED.**

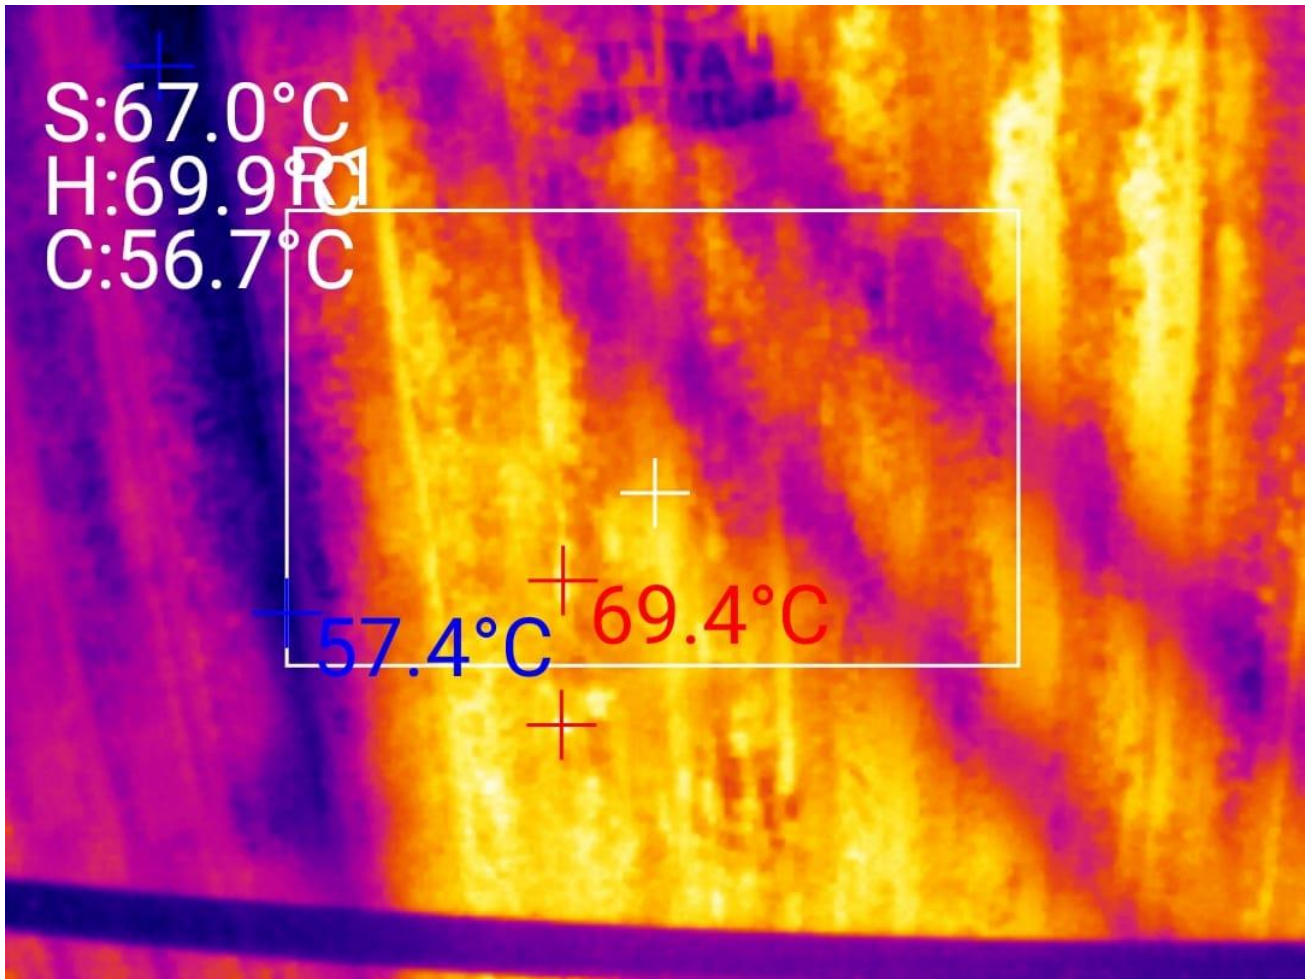
**AFTERNOON DATA BEFORE APPLICATION OF COOL PAINT FOR CORRUGATED  
STEEL SHEETS BOTTOM FACE, 3<sup>rd</sup> May 2021 (Ambient Temp. 40° C)**

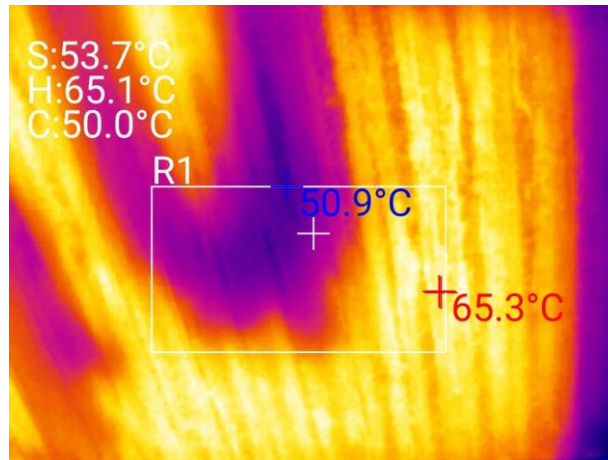
**AFTERNOON DATA BEFORE APPLICATION OF COOL PAINT FOR CORRUGATED STEEL SHEETS BOTTOM FACE, 4<sup>th</sup> May 2021 (Ambient Temp. 40° C)**

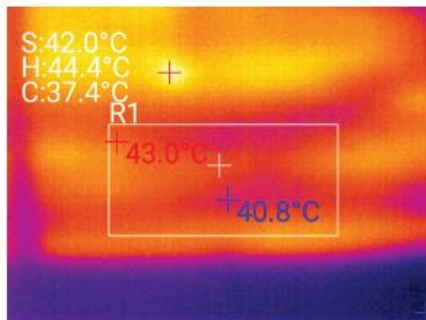
**AFTERNOON DATA AFTER APPLICATION OF COOL PAINT ON CORRUGATED STEEL SHEET BOTTOM FACE, 11<sup>th</sup> June 2021 (Ambient Temp. 37° C) COOL PAINT**

<b>File name:</b>	20210611145108.hir	<b>Emissivity value:</b>	0.95
<b>Date of saved image:</b>	20210611145108	<b>Ambient temperature:</b>	25.0°C
<b>GPS info:</b>	22.503056,73.00472	<b>Reflected Temperature:</b>	25.0°C
<b>Max temp value:</b>	44.0°C	<b>Min temp value:</b>	37.0°C

Name	Type	Temp
R 1	Max	43.0°C
	Min	40.8°C
	Average	42.1°C

**SO, REDUCTION OF 65.3 – 43.0 = 22.3 °C OBSERVED FOR COOL PAINT**

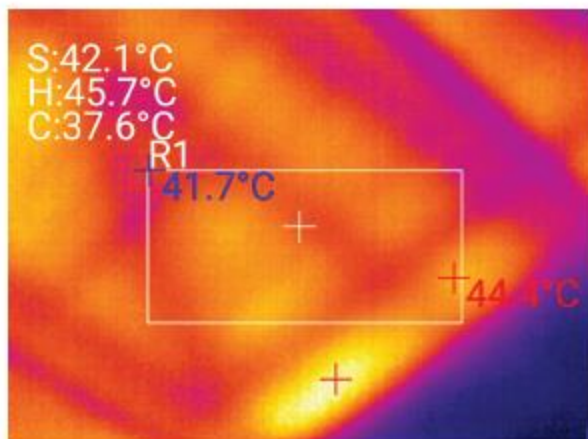
**AFTERNOON DATA AFTER APPLICATION OF COOL PAINT ON CORRUGATED STEEL SHEET BOTTOM FACE, 11<sup>th</sup> June 2021 (Ambient Temp. 37° C) KHADI PRAKRUTIK PAINT**

<b>File name:</b>	20210611145010.hir	<b>Emissivity value:</b>	0.95
<b>Date of saved image:</b>	20210611145010	<b>Ambient temperature:</b>	25.0°C
<b>GPS info:</b>	22.503056,73.00472	<b>Reflected Temperature:</b>	25.0°C
<b>Max temp value:</b>	45.0°C	<b>Min temp value:</b>	37.0°C

Name	Type	Temp
R 1	Max	44.4°C
	Min	41.7°C
	Average	42.8°C

**SO, REDUCTION OF 65.3 – 44.4 = 20.9 °C OBSERVED FOR KHADI PRAKRUTIK PAINT. THUS, DIFFERENCE IN REDUCTION IS 22.3-20.9=1.4 °C ONLY BETWEEN COOL PAINT AND KHADI PRAKRUTIK PAINT. MORE EXPERIMENTS AND ECONOMIC ANALYSIS SHOULD BE CARRIED OUT TO FIND OUT THE OPTIMUM PAINT.**

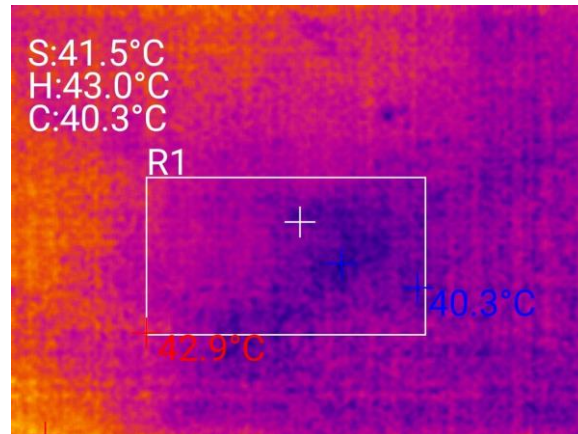
**AFTERNOON DATA BEFORE APPLICATION OF COOL PAINT FOR RCC SLAB  
BOTTOM FACE, 4<sup>th</sup> May 2021 (Ambient Temp. 40° C)**

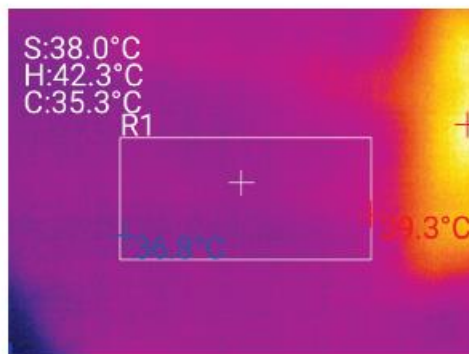
**AFTERNOON DATA AFTER APPLICATION OF COOL PAINT FOR RCC SLAB  
BOTTOM FACE, 11<sup>th</sup> June 2021 (Ambient Temp. 37° C)**

File name:	20210611145032.hir	Emissivity value:	0.95
Date of saved image:	20210611145032	Ambient temperature:	25.0°C
GPS info:	22.503056,73.00472	Reflected Temperature:	25.0°C
Max temp value:	42.0°C	Min temp value:	35.0°C

Name	Type	Temp
R 1	Max	39.3°C
	Min	36.8°C
	Average	38.1°C

**SO, REDUCTION OF 40.3 – 39.3 = 1 °C OBSERVED. HERE ALSO REDUCTION IN TEMPERATURE IS LESS FOR SLAB AS OBSERVED IN ANGANWADI.**
